WARD DAM

NH 00262

PHASE I INSPECTION REPORT
NATIONAL DAM INSPECTION PROGRAM

DECEMBER 1980

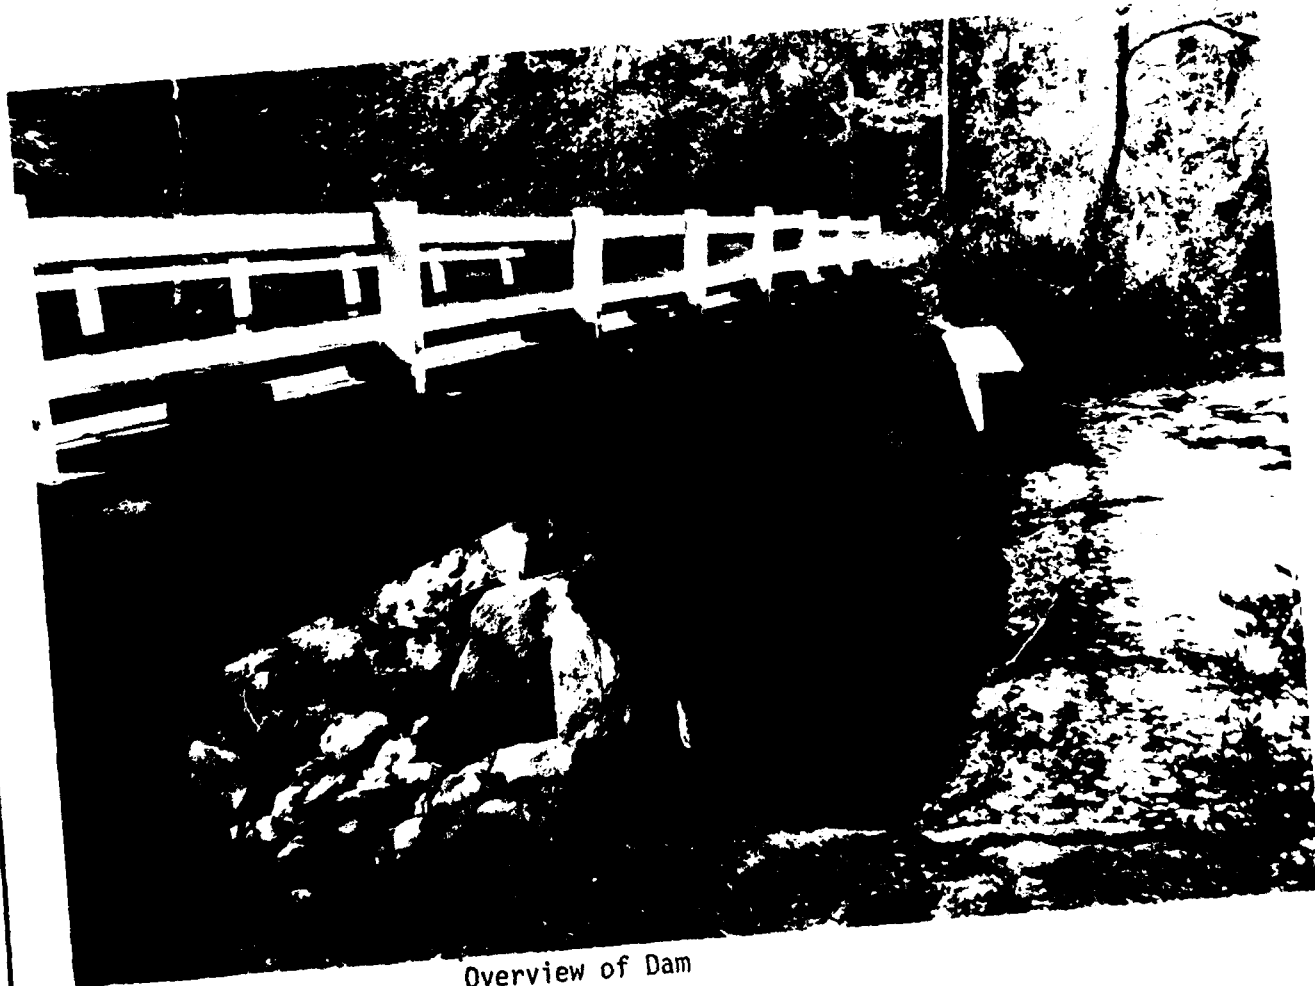
Overview of Dam

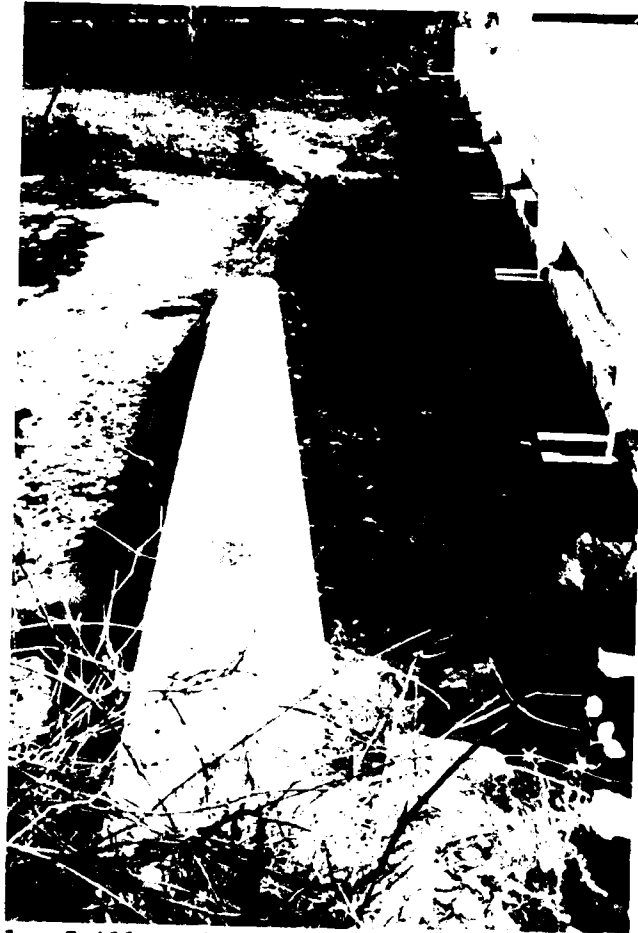
1. Spillway Crest From Right Abutement
